COLLAPSE AND REHABILITATION OF STEEL TANKS ROOF STRUCTURES

F. Turcic^{1,*}, I. Luketina, M. Plisic

¹*Civil Engineering Institute of Croatia, Zagreb, Croatia*
Department of Steel structures

ABSTRACT: Steel roof structures of two identical cylindrical heating oil tanks, located in Zagreb, Croatia, suffered great deformations and partly collapsed in 1993 and 1994, after two decades of continuous use. The tanks are each 20,000 cubic meters in volume, 45.7 m in diameter, 12.5 m in sheathing height, and each of them has a central column in the middle. The cause of damages has been analyzed. An account is given to poor original design, with respect to relevant influences: all types of loads, adequate static system and boundary conditions for individual load types. Necessary additional calculations have been performed and described. The mechanism of the activation and development of the damages are explained. Solutions implemented in the rehabilitation works are also presented. The results and analyses are presented in detail, as they are deemed highly instructive and of interest to a variety of professionals. The tank type analyzed in this paper can be considered as an internationally

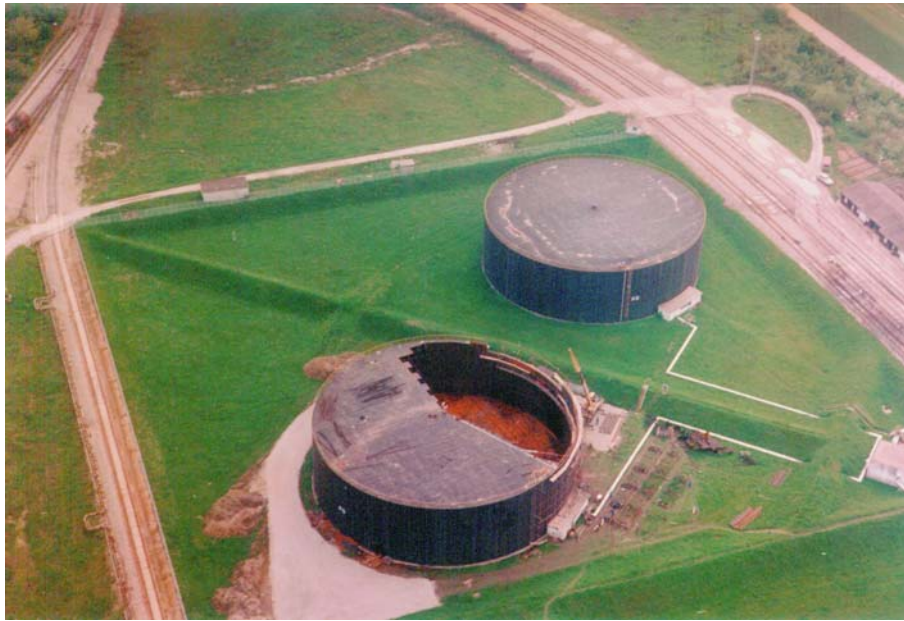
Figure 5. View of Tanks R5 and R6 (R5 during the Rehabilitation Stage)

The above described damage can be seen in Figures 5, 6, 7 and 8.

- (1) All roof truss parts or elements at sheet metal and sheathing levels, that either collapsed or were affected by plastic deformation, were replaced. Central column was corrected in designed position.
- (2) All roof truss members were strengthened so as to be able to withstand the service load of 1.25 kN/m^2 , which were defined as necessary through calculations.
- (3) The hollow steel-made central column was filled with concrete.
- (4) Four latticed bracings were added on the tank R6 in order to further stabilize the top chord of roof trusses at the roof level.
- (5) The central column footing was fillet-welded along the circular perimeter to the sheet metal at the tank bottom level.
- (6) Node 9 at the bottom chord was laterally linked to purlins by diagonal bracing.

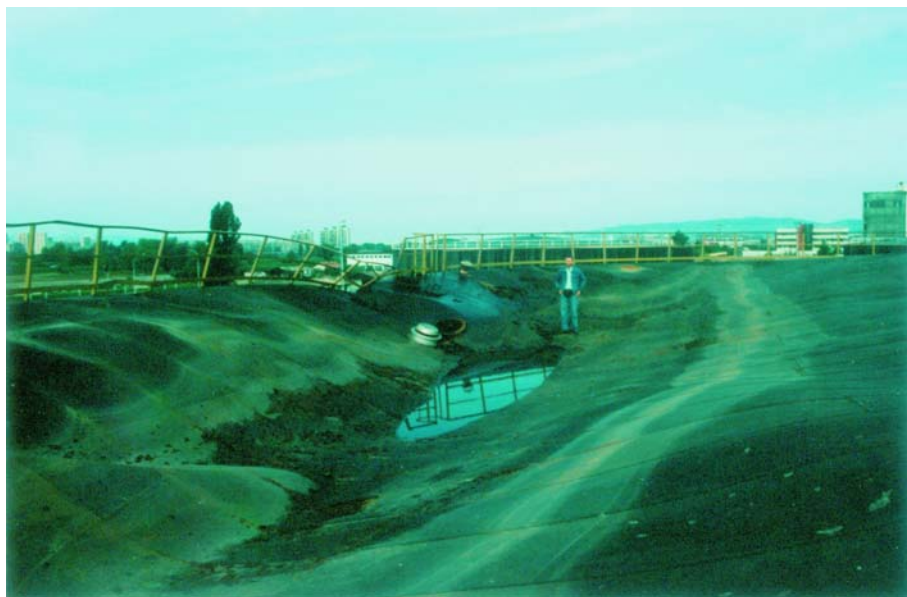
- (1) About 40 percent of the roof area caved in through shell penetration, including also the roof trusses XIII, XIV, XV, XVI and I. Thus a depression in form of an ellipse shaped basin (1.75 m in maximum depth, with ellipse axes 35 and 15 m in length) was created on the roof surface.
- (2) Last two envelopes of the sheathing, together with edge bracing and railing on about 1/3 of the perimeter (about 45 m) are heavily deformed and damaged.
- (3) The following roof truss members failed either due to axial tensile forces or bending action along nodes (Table 1):

Figure 6. Form of Depression on the Roof Surface

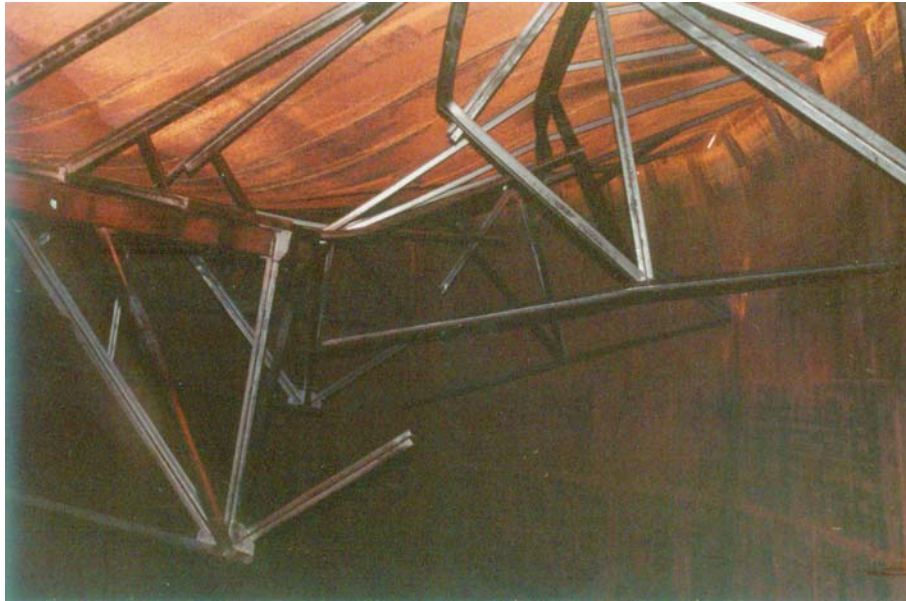
Truss No.	Element No.	Place of failure
I	2	next to node 2
	11	next to node 12
	12	next to node 14
	24	in the middle
XIII	9	next to node 9
XIV, XV	2	next to node 3
XVI	12	next to node 13 and 14
	24	in the middle

Figure 7. Broken Roof Trusses

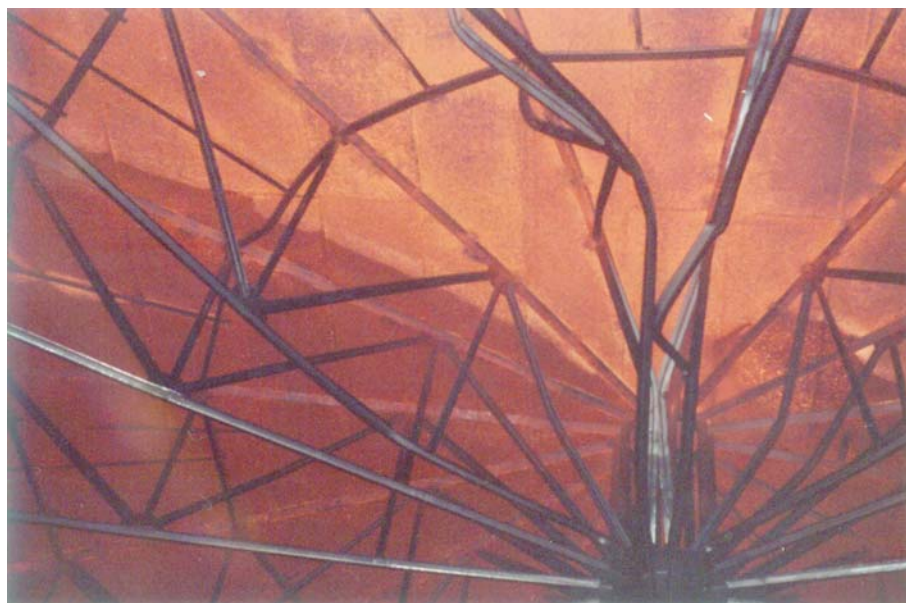
Truss No.	Element No.	Place of failure
XIII	14	in the plane
I, II, IX, X, XI, XIII, XIV, XV, and XVI	7, 8, 9 and 10	outside of the plane
I, XIII, XIV, XV and XVI	36, 37 and 40	outside of the plane

- (5) The foot of the central column moved from the initial position by 105 mm, approximately in the direction of the truss no. XI.
- (6) In the zone of roof collapse, the first bearing member to collapse was the purlin INP 18 which is connected to truss no. I in node 13. This was followed by failure of several elements of the rafters L65-65-6.

Figure 8. Deformed Roof Trusses in the Vicinity of the Central Column

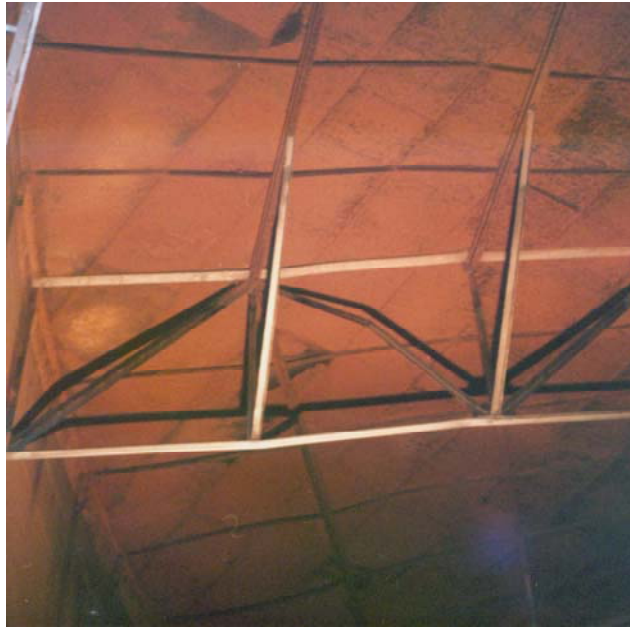
Truss No.	Element No.	Type of damage
I to XVI	24	plastic buckling
I to XVI	2 and 12	plastic deformations
IV, V and VI	11	plastic buckling
VIII	23	plastic buckling

- (3) The deflections on the roof surface are such that rainwater remains on the roof despite the roof slope. Typical appearance of roof girder deformations on R6 is shown in Figures 9, 10 and 11. Figure 9 shows the appearance of damaged roof truss members, Figure 10 indicates the deflection with water pools on the roof and Figure 11 depicts the displacement of the central column footing.

Figure 9. Damaged Roof Truss Members

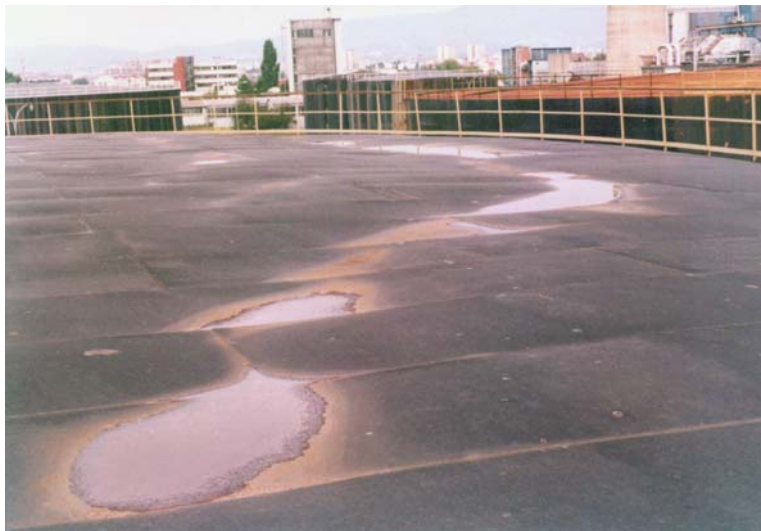
Figure 10. Depressions on the Roof Surface

This field of the truss, after buckling of the member 24, acts as a frame, resulting in deformation of chord members 2 and 12 due to bending along nodes. At this time, initial downward deflections begin to form in the area around nodes 13 and 14. Rainwater gradually accumulates in these deformed zones.

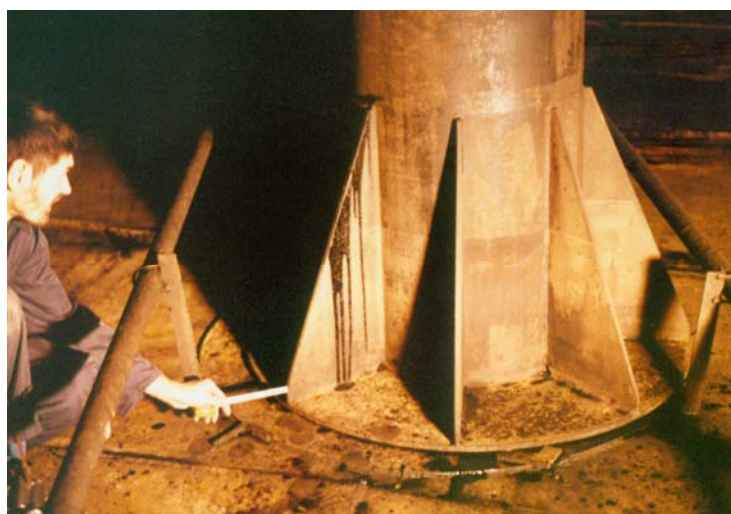
- (1) The footing of the central column (node 45) deviated from design position by 11 cm.
- (2) The following roof truss members were damaged (Table 3):

Figure 11. Central Column Footing Displacement

The question should now be put as to why and when the central column footing in node 45 were displaced at tank R6 (i.e. in initial phase of damage development and again in 1996.), and at tank R5 (registered after final collapse).

Roof trusses are characterized by structural continuity in the zone above the central column. In case of sudden loss of stability of compressed members 9 and/or 10 of the bottom chord in a group of roof trusses (which are due to unsymmetrical wind load subjected to maximum load, or are geometrically weaker than others), the connection at the top of the central column rotates and moves the central column footing in the lateral direction. This movement is instantaneous and strong, resulting in the breakdown of weak restrainers.

- (1) The fillet weld, by which the central column footing was linked to the base, was removed.
- (2) Roof truss supported on the central column, in nodes 11 and 23, were converted from fixed supports to movable supports.

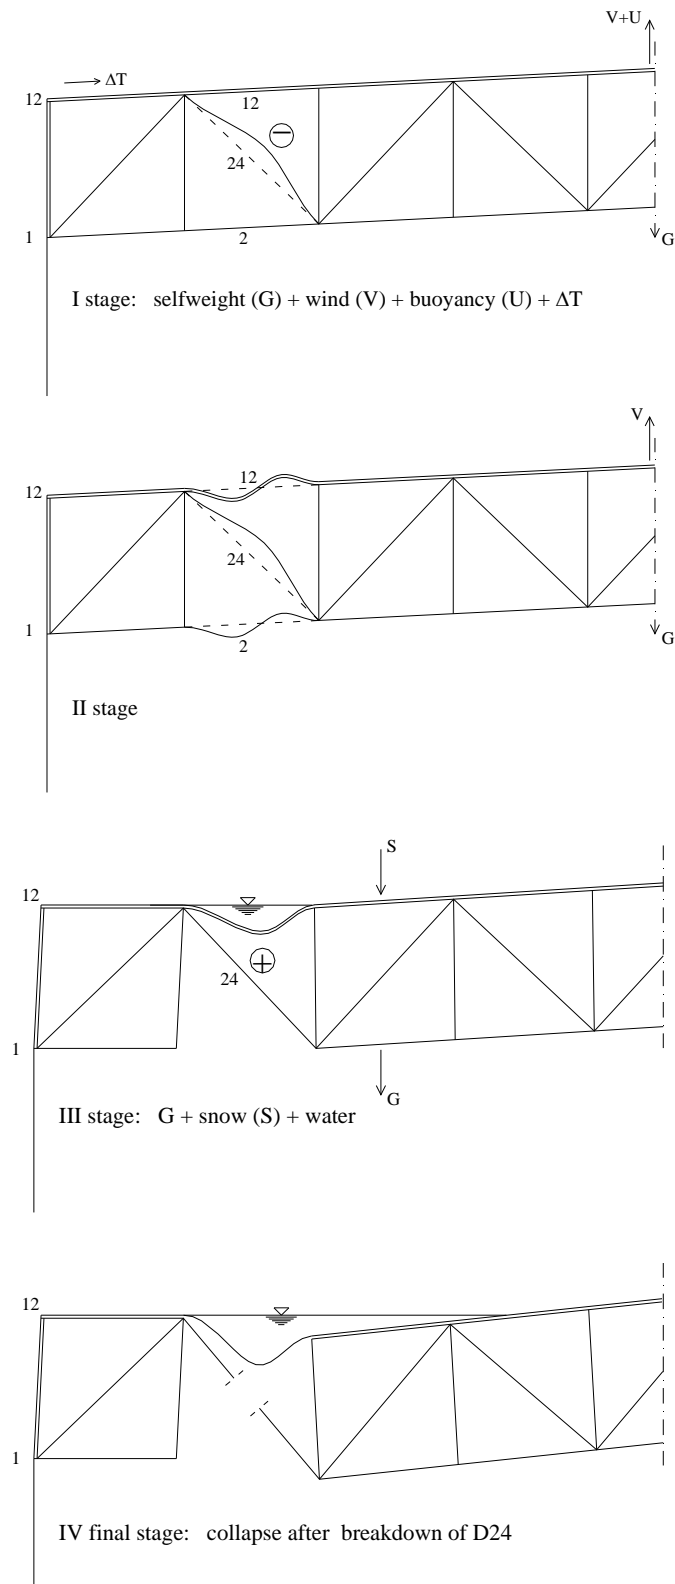
It is only at this stage that this phenomenon was noted at the tank R5 in 1993. The failure stages are shown in Figure 12.

Figure 12. Stages of Damage Development

It can be seen from the photograph of the roof metal sheet area in the valley that the process lasted for some time. The mud and corrosion isohypse traces show several valley filling levels, and point to longer periods of rainwater deposition and evaporation.
