EXPERIMENTAL TEST SIMULATING A COLUMN LOSS IN A COMPOSITE FRAME

Jean-François Demonceau* and Jean-Pierre Jaspart

University of Liège, Argenco Department, Chemin de Chevreuils, 1 B52/3 4000 Liège, Belgium

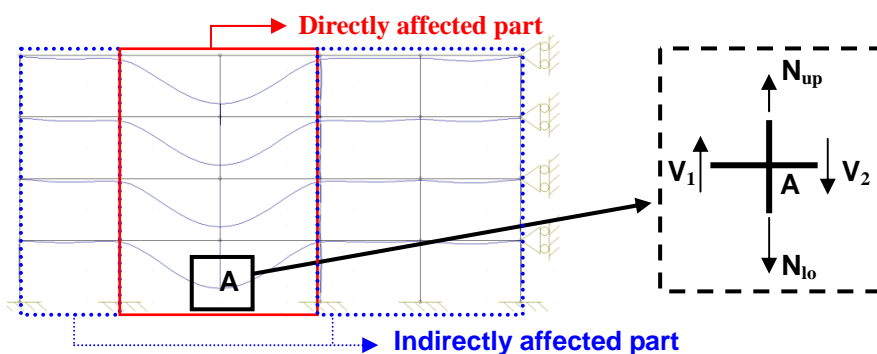
Figure 1. Representation of a Frame Losing a Column and Main Definitions

When a structure is losing a column, for instance further to an impact, it may be divided in two main parts, as illustrated in Figure 1:

- the directly affected part which is the one directly affected by the loss of the column, i.e. the beams, the columns and the beam-to-column joints which are just above the impacted column and;
- the indirectly affected part which, on one side, is affected by forces transferred from the directly affected part and which, on the other side, influences the response of the directly affected part.

At the top of the column, before it is fully removed (see Figure 1), the following internal forces are identified in the vertical direction:

- the shear forces V_1 and V_2 at the beam extremities;
- the axial force N_{up} in the column just above the impacted one and;
- the axial force N_{lo} in the impacted column.

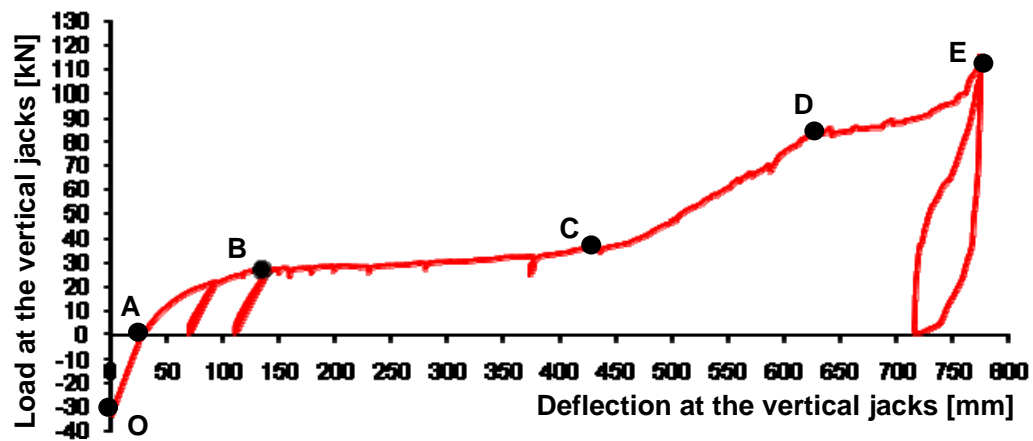
Figure 24. Vertical load vs. Vertical Displacement Curve

Then, as previously explained, a vertical displacement is progressively imposed until failure. During this stage, two “unloading-reloading” sequences are followed as illustrated in Figure 24.

From point “A” to “B” in Figure 24, the substructure yields progressively to finally form a beam plastic mechanism at point “B” with formation of the plastic hinges in the joints. At that moment, the cracks in the vicinity of the external composite joints are more pronounced and yielding of some steel components of the joints is clearly observed (column web and beam flange in compression – see Figure 25 and Figure 26). Also, for the internal composite joint, a detachment of the end-plate and of the column flange is observed (see Figure 26).

From point “B” to “C” in Figure 24, a plateau develops, what means that the vertical displacements increase with a constant vertical load (equal to 30 kN). All along the plateau, the concrete cracks in the vicinity of the external composite joints continue to extend and yielding spreads further in the

The horizontal jacks begin to be significantly activated at point “C” in Figure 24; at this point, membrane forces start to develop as confirmed by the shape of the global displacement curve (part “CD” in Figure 24). At point “D”, the longitudinal rebars in the external composite joints suddenly fail (see Figure 28) and the external joints work later on as steel ones. Yielding affects the different components in the internal and external composite joints as illustrated in Figure 29 and Figure 30. At point “D”, a loss of stiffness related to the failure of the rebars is observed in Figure 24; indeed, when these rebars fail, both flexural and tensile stiffness of the external joints decrease, what directly induces the development of further membrane effects.

However, it can be observed that the failure of the rebars does not lead to the failure of the substructure; indeed, after point “D”, the vertical load at the vertical jacks still increases with the imposed displacement (part “DE” of the curve in Figure 24).

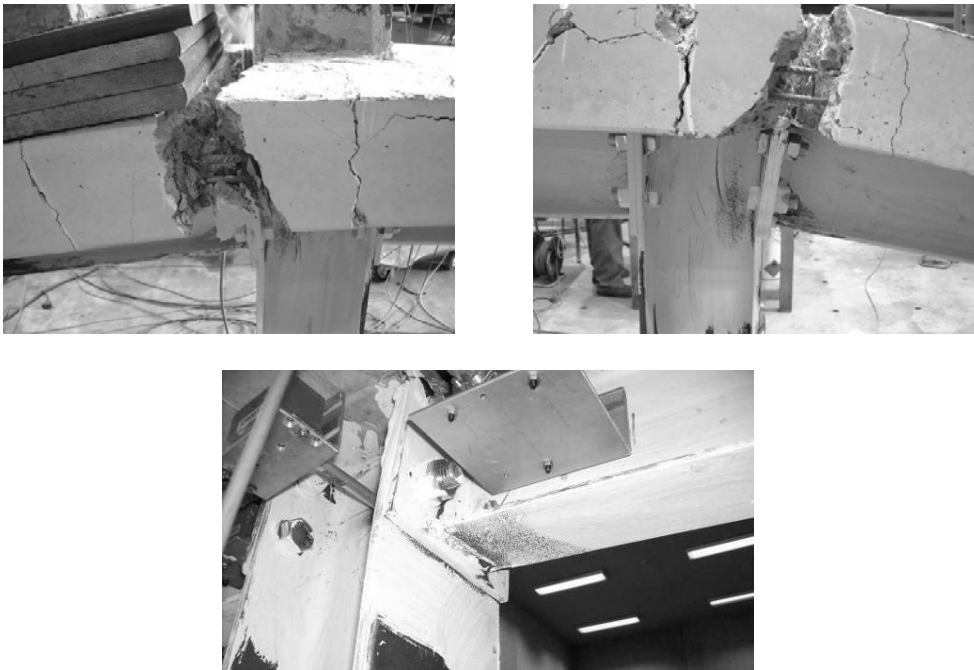
Figure 34. External Composite Joints at the End of the Test

Also, at point E of Figure 24, all the joint components of the internal and external composite joints suffer large deformations and yielding as seen in Figure 34 and Figure 35 (after the damage

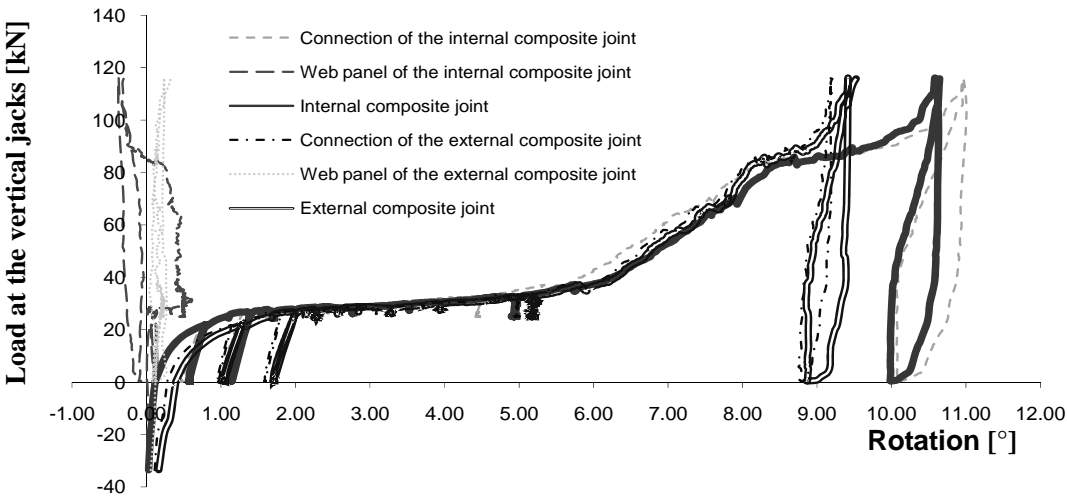
Figure 36. Rotation of the Internal and External Composite Joints

The evolution of the joint rotations versus the load acting in the vertical jacks is given in Figure 36. The maximum joint rotations reached at the end of the test are equal to 11° (192 mrad) and to $9,5^\circ$ (166 mrad), for the internal and external composite joints respectively. It can be observed in Figure 36 that:

From the maximum rotation values observed at the end of the test, it can be concluded that the joints exhibited a very ductile behaviour with a very high rotation capacity, as expected. Also, through these observations, it is confirmed that, even if the collapse mode under hogging bending moment is associated to the component “beam flange in compression”, the ductility of the joint is sufficient to develop the catenary action, as predicted in § 2.2.

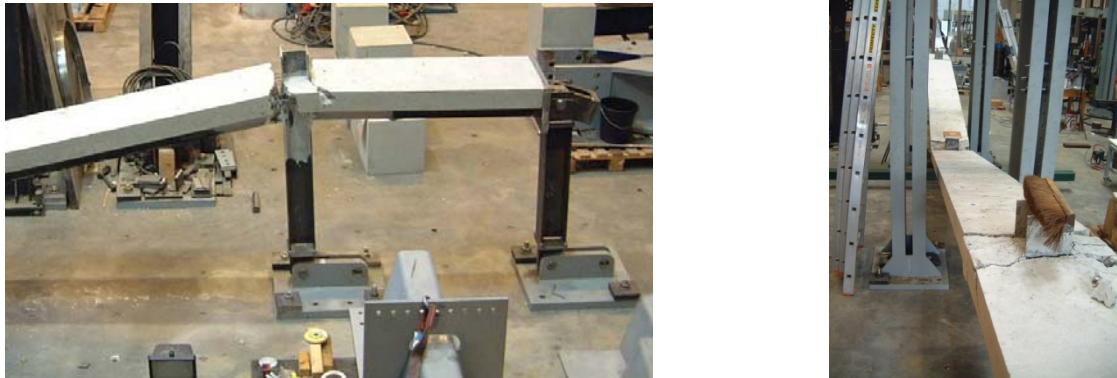
Figure 37. Distribution of the Cracks in the Concrete Slab

After the test, the steel plates and the concrete blocks were removed so as to see the location of the cracks along the concrete slab. As shown in Figure 37, two big cracks appeared during the test in the vicinity of the external composite joints. This observation can be explained by the fact that, in the tested substructure, the composite joint configuration are composed of flush end-plates with the upper part embedded in the concrete slab; so, when the end-plates deform, the embedded part deformation can easily initiate a crack in the reinforced concrete slab as illustrated in Figure 38. However, the joints exhibited a very ductile behaviour during the test although to have one big crack is not the best situation from the ductility point of view.
