AN EXPERIMENTAL STUDY ON SEISMIC PERFORMANCE OF STEEL COMPOSITE BEAM-COLUMN RIGID JOINT AND BUCKLING RESTRAINED KNEE-BRACED JOINT

Steel structure;
Combined beam-column joint;
Buckling restrained knee brace;
Quasi-static test;
Seismic performance

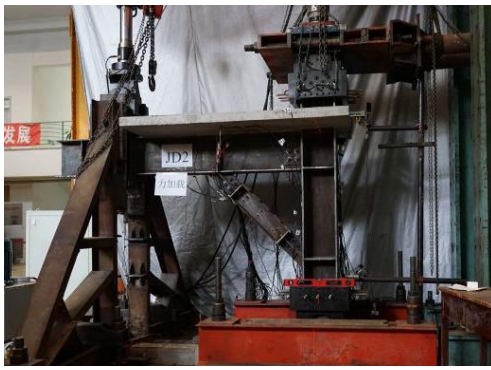
(b) BRKBJ experimental device diagram

The loading device of this test is depicted in Fig. 3. Two vertical actuators are linked with the reaction frame, and a horizontal constraint is linked with the reaction wall. The reaction frame and the lateral constraint are connected to the ground by anchor bolts. The test was conducted by MTS to impose a low cyclic load on the beam end to observe the joint's failure process and to analyze the energy dissipation capacity. In preloading, the parts of the component were closely contacted to ensure the whole device's stability, reliability, and normal use. In formal loading, first, a constant vertical load of 830 kN was applied with a jack along the axial direction of the column top. The loading process, mainly composed of two stages, was adopted at the beam end. The first stage was the elastic stage, in which the components did not enter the yield state. In the elastic stage, the load was increased by integral multiples of 25 kN. When any cross-section reached the yield point, and the plastic deformation occurred, it entered the elastic-plastic stage, i.e., the second stage. At this time, the load was increased with integral multiples of yield displacement. Note that each load cycle was two weeks. When the bearing capacity of the specimen decreased to less than 85% of the ultimate bearing capacity or when a large deformation or failure occurred in the beam, column, and joint area, the loading was stopped, and the test was complete.

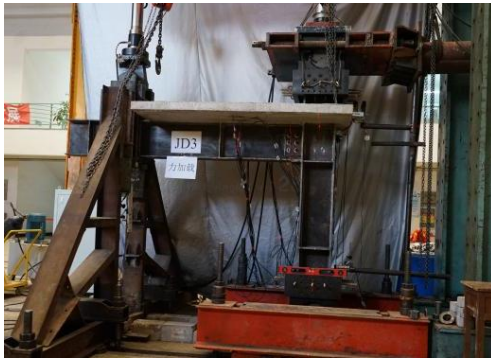
(c) BTCRJ experimental device diagram

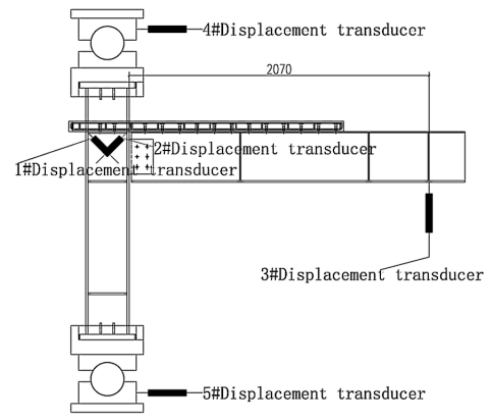
(b) BTCRJ displacement sensor layout

Fig. 4 Layout of displacement sensors of joints

BRKBJ arrangement of 6 displacement meters, BTCRJ specimen arrangement of 5 displacement meters. The displacement meters No. 1 and No. 2 were used for monitoring the diagonal displacement of the beam and column joint domain. The displacement meter No. 3 was used to monitor the displacement of the beam end loading point. The displacement meters No. 4 and No. 5 were used for monitoring the displacement of column ends. The displacement meter No. 6 was used to monitor the axial tension and compression deformation displacement of the buckling restrained corner brace. The strain of the beam, column joint domain, corner brace, column intersection point, and the beam-column near the joint were observed. Note that the strain gauge numbers of both joints near the joint domain were the same. The displacement meter and the arrangement of key measuring points are illustrated in Fig. 4 and Fig. 5.

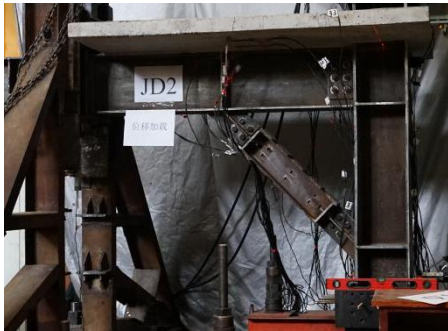
Fig. 6 BRKBJ knee brace yield

In the elastic loading stage, when the vertical load of 154.2 kN along the pressure direction was applied to the beam's end, the strain at the gauge No. 52 at the core of the buckling restrained corner brace reached $1358\mu\epsilon$, which is the maximum of all strains of the core. As shown in Fig. 6, It can be determined that the core material part yields at this time, and the yield strength is measured by the material performance test of the sample. After one loading cycle in the elastic loading stage, the maximum displacement along the beam's pressure direction was 7.6 mm. Thus, the yield displacement was 7.6 mm, and the yield load was 154.2 kN. The cyclic load was carried out with the integral multiple yield displacement, and each stage was loaded twice. As shown in Fig. 7, when the vertical displacement imposed by MTS at the beam end along the compressive direction reached 10.51 mm, the load at the beam end was 195.4 kN, and cracks appeared in the middle of the concrete slab. Also, when the displacement applied by MTS at the beam end along the compressive direction

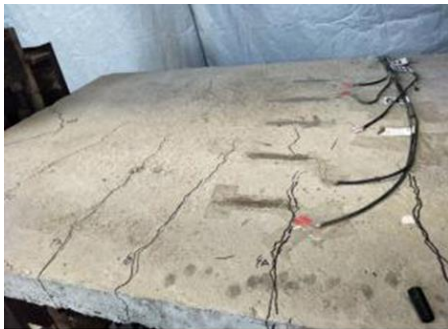
Fig. 8 Crack on the concrete floor

reached 21.1 mm, the corresponding load was 290.71 kN, and the maximum strain of the reinforcement in the upper floor reached 1390. Thus, the reinforcement was expected to yield at this time. When the vertical displacement applied by MTS at the end of the beam along the compressive direction reached 24.13 mm, the load at the end of the beam reached 346.61 kN. The data monitoring reveals that the maximum strain measured by strain gauge No. 41 at the lower edge of the beam and corner brace is 1798. Thus, the yield of the beam can be determined at this time. When the vertical displacement applied by MTS at the beam end along the compressive direction reached 32.34 mm, the load at the beam end was 333.38 kN. As shown in Fig. 8, the concrete slab detached from the steel column, and the penetrating cracks appeared in the middle of the slab. Fig. 9 shows that the fracture occurred in the middle of buckling restrained knee-braced core material when the load is up to 9 times the yield displacement. At this point, the connection between the beam and the corner brace yielded, while the beam end near the joint domain did not yield. When the load to the buckling restrained corner brace reached 11 times the upward yield displacement, a crack with a width of 8 mm appeared on the floor, the floor edge began to fall off, and the bearing capacity of the specimen decreased to less than 80%. At this point, the test is complete. The buckling restrained corner brace was broken, a large crack on the concrete slab and many penetrating cracks appeared, and the slab fell off. However, the beam and column were not damaged and unstable, and the beam-column joint domain maintained good mechanical properties, which was consistent with the two-stage yield design concept of the BRKBJ specimen.

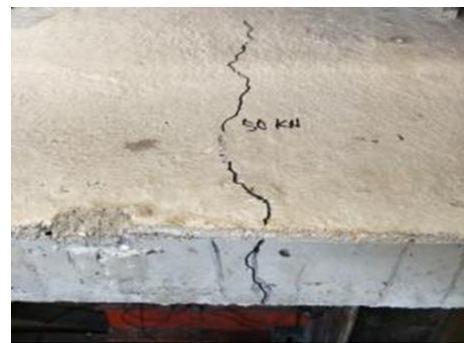
Fig. 10 Crack on the concrete floor

Fig. 10 suggests that, in the elastic loading stage, when the force was loaded to 50 kN, cracks appeared near the joint domain of the floor and fell off. When the force was loaded to 140 kN along the pressure direction, penetrating cracks appeared near the joint domain of the floor. When a vertical load of 226 kN was applied in the direction of pressure, the strain at the root of the lower flange of the beam, at gauge No. 37, reached $1908 \mu\epsilon$, the maximum value recorded among all strains. Moreover, a clear inflection point appeared on the load-displacement curve of the beam endpoint. Thus, the yield of the beam can be realized at this time, which was after one loading cycle in the elastic loading stage. The load-displacement curve also shows that the maximum displacement of the beam endpoint along the pressure direction reached 20 mm. The yield displacement was 20 mm, and the corresponding yield load was 226 kN. It should be noted that 20 mm integral multiple yield displacements were used to increase the cyclic load amplitude. At each displacement stage, the loading cycle was imposed twice. When the vertical displacement along the pressure direction applied by MTS at the beam endpoint reached 28.74 mm, the load at the beam endpoint was 290.71 kN, and the maximum steel bar strain at the upper floor reached $1472 \mu\epsilon$. It can be realized that the steel bar yielded at this time. When the vertical displacement in the compression direction applied by MTS at the beam endpoint reached 60 mm, the load at the beam endpoint was 305.98 kN, and cracks appeared near the joint domain of the floor. When the load reached 4 times yield displacement, the lower flange of the beam near the joint domain buckled, and the load at the beam endpoint was 313.5 kN (Fig. 11). When the loading was up to 6 times the yield displacement, the lower flange and web of the beam near the joint domain were torn (Fig. 12). At this point, the test was terminated.

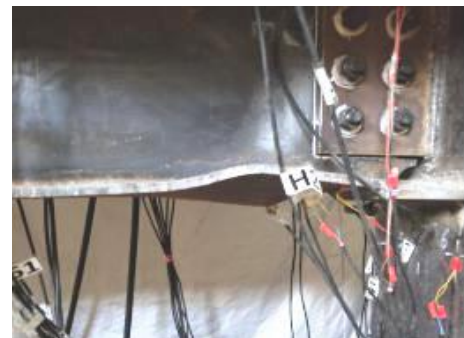
Fig. 11 Beam flange deformation

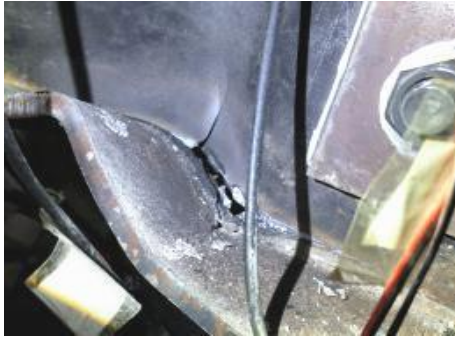
Fig. 12 Beam flange failure

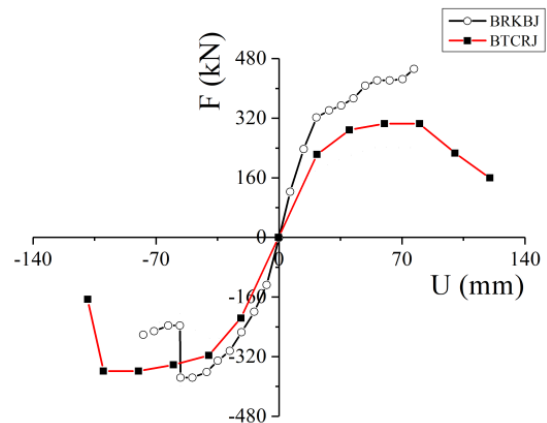
Fig. 15 Comparison of skeleton curves of BRKBJ and BTCRJ specimens

The skeleton curves of both specimens are compared as illustrated in Fig. 15. The ultimate bearing capacity of the BRKBJ specimen is 453.73 kN. The skeleton curve of the specimen changes linearly before the buckling restrained corner core material yields. The whole specimen is in the elastic stage. After the core material yields, the skeleton curve has obvious bending. Meanwhile, with gradually increasing the displacement, the specimen stiffness gradually decreases. After the beam and column yield, the stiffness will decrease again. The skeleton curve has an obvious inflection point. When the BRKBJ specimen is loaded in the tensile direction to 9 times the yield displacement of the energy dissipation knee brace, the middle part of BRKBJs fractured. Before the fracture of the core material, the displacement and stiffness in the tensile and compressive directions are symmetrical, indicating that the floor slightly influences the BRKBJ specimen's stiffness. The ultimate bearing capacity of the BTCRJ specimen is 342.14 kN, and the skeleton curve changes linearly before the beam and column yield. After the beam and column yield, the stiffness decreases significantly when the displacement in the compressive direction reaches 80 mm. However, the stiffness begins to decrease when the displacement in the tensile direction reaches 105 mm, indicating that the floor has a significant enhancement effect on the stiffness in the BTCRJ specimen's tensile direction. The loads and corresponding displacements of both specimens at each stage are shown in Table 3. It can be realized that setting BRKBJs can effectively increase the yield displacement of beam and column, improve the yield strength, and effectively delay the cracking of concrete and the yield of steel bars. The ultimate bearing capacity increases by 32.6%, and the displacement decreases by 19.2% under ultimate load.

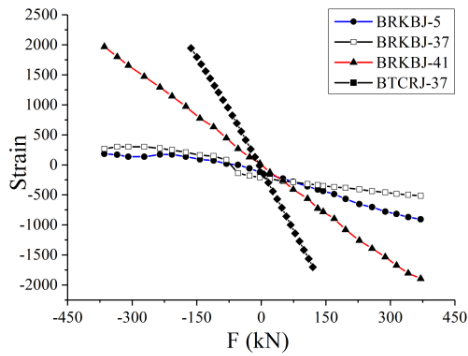
Fig. 18 The yield-strain curves of BRKBJ and BTCRJ specimens

The strain changes of measuring point 5 at the connection between the column and the knee support of the BRKBJ specimen, measuring point 41 at the connection between the beam and the knee support, and measuring point 37 at the beam endpoint near the joint domain are plotted in Fig. 18.

The yield load at the connection between beam and knee brace support of the BRKBJ specimen is significantly greater than that at the beam end of the BTCRJ specimen. At this time, no yield occurs at the connection between the column of the BRKBJ specimen and the knee brace support and near the joint domain. This phenomenon can indicate that the layout of BRKBs can effectively absorb energy. In the later loading stage, the knee braces and the beam near the connection of knee braces take energy. Thus, not only the yield-load curve of the whole beam and column is improved, but also the formation of plastic hinges at the beam end near the joint domain is prevented. Therefore, the overall energy dissipation capacity of the whole joint domain is improved.
