DURABILITY EVALUATION OF REPAINT-COATING ON STEEL WITH INITIAL PAINT – COATING REMOVED BY INDUCTION HEATING

Sota Inoue ¹, Mikihito Hirohata ^{1,*} and Tomonori Nakahara ²

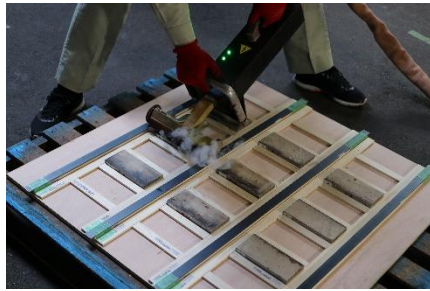
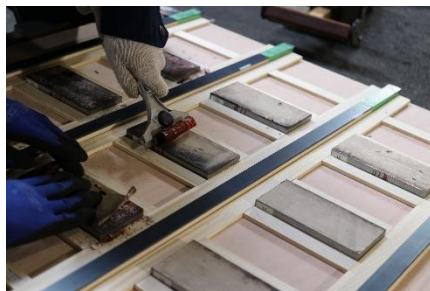
Fig. 4 Procedure of paint-coating removal by IH

Fig. 4 shows the situation of IH paint-coating removal in this experiment. The induction heating coil manufactured by RPR Technologies was used as the heating device. When heating, the moving speed of the induction head was adjusted so that the temperature of the steel surface of specimen was 200 °C. Fig. 5 shows an example of the specimen surface after the paint-coating removal. The black areas on the surface are the steel substrate, the white area is the primer of the initial paint-coating, and reddish-brown area is the undercoat. Although the degree of paint-coating remaining on each specimen was different, the upper layer of paint-coating could almost be removed from the undercoat. Possible reasons for the differences include variations in the heating temperature and the positions where the scraper blade attached.

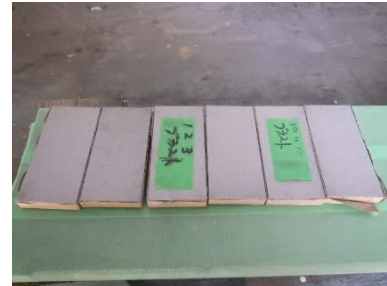
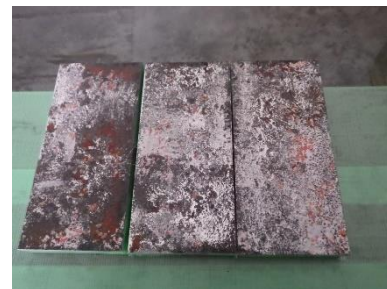
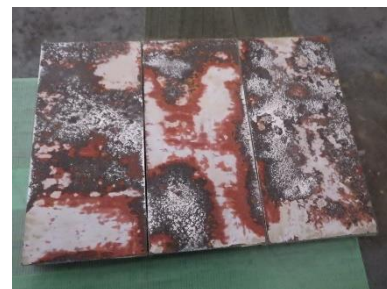
Fig. 6 Specimens after surface preparation

Fig. 6 shows the appearance of the specimens after surface preparation. In Type-I and Type-II, whole steel surfaces are exposed by blasting or power tools. Therefore, there was no difference in the surface condition depending on whether IH paint-coating removal was applied or not. On the other hand, Type-III specifies that the paint-coating maintains sound adhesion to the steel should be left. In this experiment, the specimens with IH paint-coating removal remained some parts of the undercoat, while the specimens without IH paint-coating removal remained some parts of the topcoat which seemed to be sound.

- (1) IH paint-coating removal was able to remove most of the upper layer of paint-coating from the undercoat on the actual bridge.
- (2) After surface preparation, the condition of the steel substrate differed depending on whether IH paint-coating was applied prior to Type-III surface preparation only removing deteriorated paint-coating. On the other hand, no difference in the steel substrate was observed in Type-I and Type-II surface preparation removing all of rust and paint-coating.

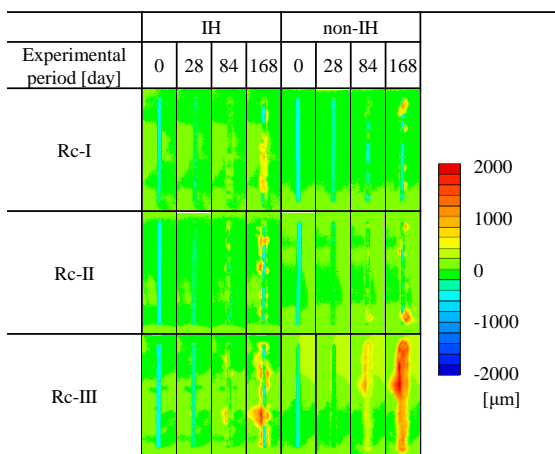
Fig. 12 Surface topography of specimens

It is known that in paint defect area reaching the steel surface, the steel just below the scratch acts as the anode and the steel under the paint-coating near the defect area acts as the cathode. Therefore, the large defects reaching the steel substrate cause blistering of the surrounding paint-coating by the mechanism shown in Fig. 13 [5]. In this experiment as well, blistering occurred near the initial defects. The height and extent of the blistering increased as the testing days progressed. This blistering might occur by the mechanism shown in Fig. 13. In this study, "blistering area" was defined as an evaluation index for paint-coating deterioration. This index indicates the area where the height of the paint film was more than 50 μm compared to the state before the experiment. The surface topography data measured by the laser displacement meter was used to calculate the blistering area.
